**PROJECT REPORTS**  
**Bentofix® X (PE coated GCL)**

## Bentonite Sealing Mat Wakes Sleeping Beauty

### Bentofix® secures Weinmann and Schanz's new logistics center in Balingen

**Fuel Depot Protection: Always 100% Secure**  
**Bentofix® X protects against drying out**

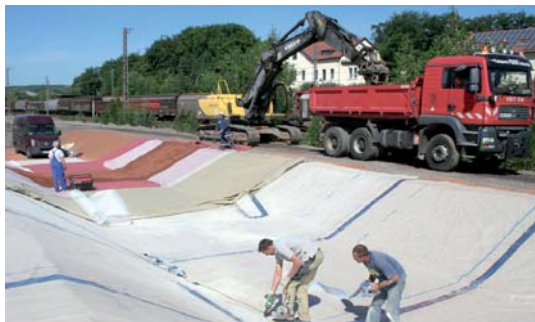
**Figure 1**  
Taping of  
Bentofix®  
overlaps

In redeveloping the site and making the water gardens possible, the initial planning phase looked at using a 500mm-thick compacted clay as a seal. However, this sealing system would not have worked with the many known and anticipated penetrations and connections to structures, such as concrete stairs, pipes, foundations, old and new walls, etc. With Bentofix® X, the concerns were resolved. Batten strips secured the Bentofix® panels to structures and appurtenances to ensure firm seals throughout the system.

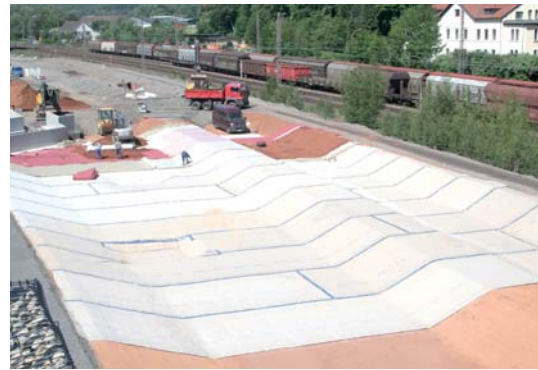
**Figure 2**  
Bentofix® X sealed  
section and cover  
soil placement

To ensure that the PE coated GCL was not damaged during installation, a needle-punched Secutex® R 404 nonwoven was placed under and over the GCL. Since the subgrade material was expected to be very coarse in several places, the designers wanted to ensure that the bottom geotextile of Bentofix® would not be damaged. For this reason, Secutex® was laid under the Bentofix® GCL. Secutex® on top of Bentofix® protects the PE coating from being damaged during the cover soil placement process, as well as during the service life against any loads occurring from above.

Overall, 25,000m<sup>2</sup> of Bentofix® X2 BFG 5300 and twice that amount of Secutex® R 404 were installed according to the following cross-section (from top to bottom):

- Pond beds with different types of vegetation
- Nonwoven protection geotextile, Secutex® R 404
- GCL, Bentofix® X2 BFG 5300
- Nonwoven protection geotextile, Secutex® R 404
- Leveling material for subgrade (aggregate 0/16mm)
- Subgrade

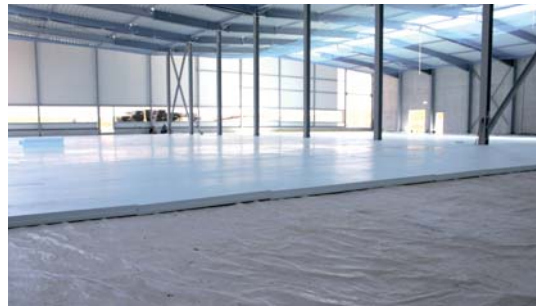
Figure 3  
Insulation placed directly over the coating side of Bentofix® X

In Balingen, this innovative geosynthetic solution involved the encapsulation of the rock layers that were at risk of drying out. The sealing product used was NAUE Bentofix® X2 BFG 5300, a polyethylen (PE) coated GCL that's characterised by extremely low permeability.

The installed GCL over the subgrade and under the concrete foundation minimizes, if not even prevents an evaporation processes in the sealed zone. The potential threat of structural damage to the foundation due the potential risk of volume increase of the Lias rock during dehydration was mitigated.

Bentofix® provided numerous welcomed benefits. One of them was that the installed GCL qualified as an smooth and flat surface for the installed insulation under the concrete slab. Additional security was derived from the multi-functionality of the GCL's composite structure. The high-swelling bentonite component of GCL acts as a "self-sealing" barrier, in the event that the robust polymer coating is accidentally damaged.

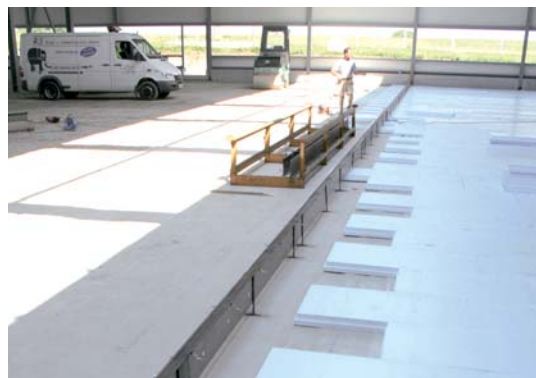
Figure 4  
Preparation for the concrete pouring over Bentofix® and insulation

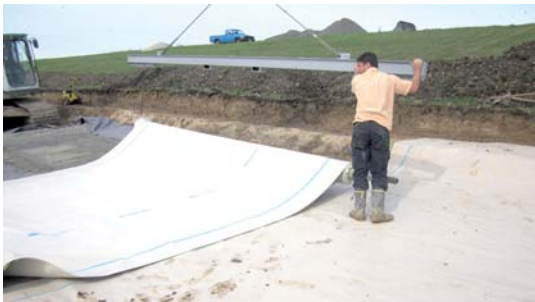
**Figure 5**  
Installation and overlapping of Bentofix® X GCL rolls

Adhered to the outer side of one of the geotextiles, this special coating protects the bentonite from drying out in difficult project environments, increases gas barrier performance, extends GCL service life, prevents ion exchange, mitigates root penetration threats, and more. Approximately 3,500m<sup>2</sup> of NAUE Bentofix® X2 NSP 4900 was installed. It was placed with the coated side up (standard installation).

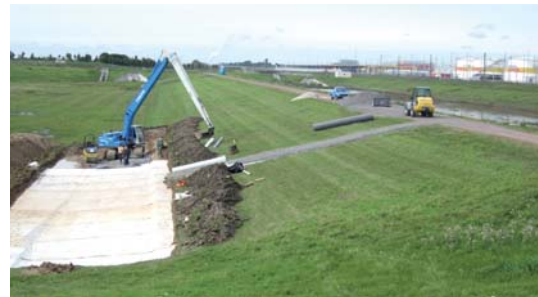
**Figure 6**  
Cover soil placement over installed Bentofix® GCL

Generally, this potential problem is circumvented by means of a 60cm cover layer on top of the GCL. At this site, however, only 30cm of cover was possible. The bentonite core, even protected by its carrier and cover layer geotextiles, would not be guaranteed to remain in a permanently swelled state. The installation of Bentofix® X2 NSP 4900 offered a strong solution: the GCL the client wanted originally but without any site desiccation questions. This innovative GCL from NAUE has further advanced the 25-year history of Bentofix® GCLs. It contains the high-swelling powder sodium bentonite core and scrimreinforced, needlepunched nonwoven geotextile encapsulation that Bentofix® is renowned for; as well as the new Bentofix® X line polyolefin polymeric coating.
